New Evidence of the Possible Danger of Loading Titanic's Lifeboats to Capacity

By Bob Read, D.M.D.

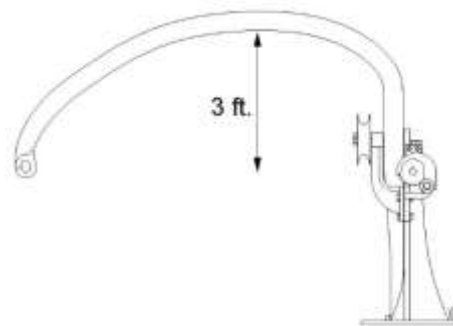
In order to simulate a fully loaded and equipped boat the water breaker in the boat was empty and there were two crew members in the boat in addition to 124 weights of 56 lbs. each. The specifics of the loading is detailed in the appendix. The boats were swung out to the gunwale. While the weights were being distributed, one of the davit arms was observed to be giving way. It twisted and was bent down until the eye of the davit was at the level of the operating screw when it stopped. Figure 1 is a recreation of the sketch which was included in the BoT documents.

The section of the last arm to break was quite sound & as shown here. The section of the first one to break was very defective & as shown in rough sketch. There was only 5/8" solid metal for 5" of the web with bad blow holes at each end as shown. The davits are of the type P2 & are 11'-4" from the center of pivot pin to the eye.

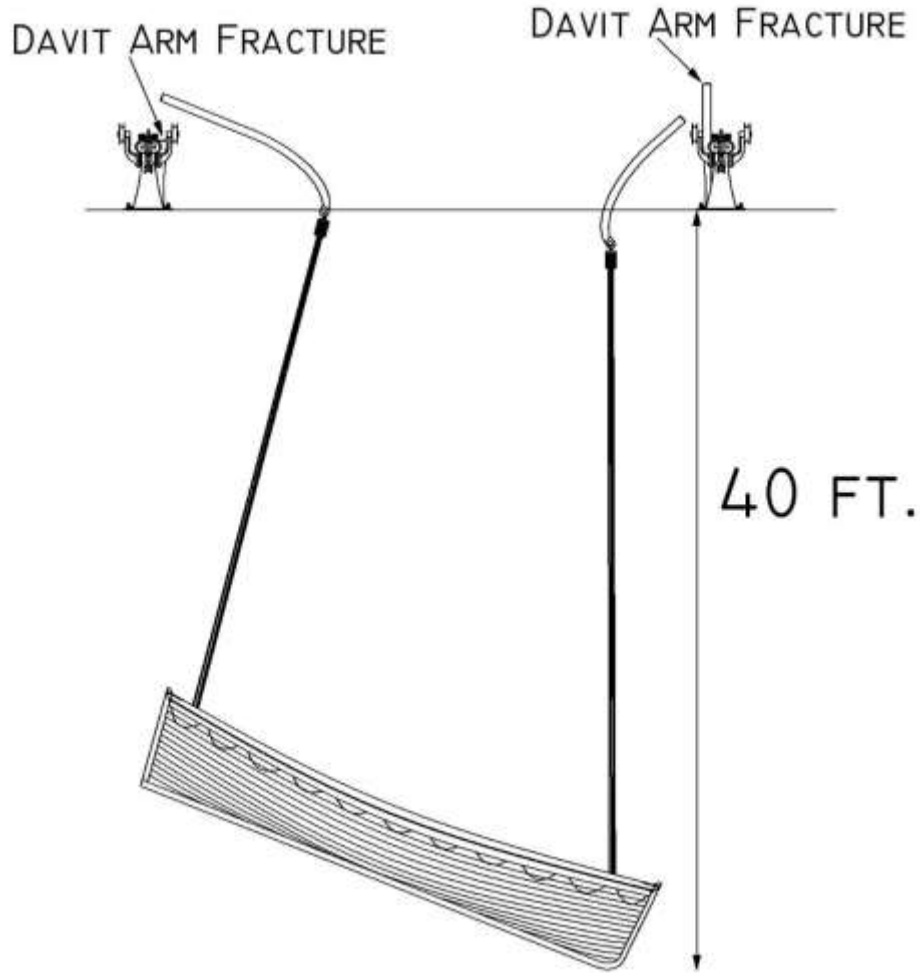
Figure 2

It was then determined that for safety reasons that the next davits and boat to be tested should be fully loaded before swinging out and that no crew should be on board. This next test proved to be catastrophic. The loaded, unmanned boat was swung out and lowered. When the boat had been lowered about 40 ft., one of the davit arms twisted and bent down, then broke about 3ft. 4in. above the pivot pins. This sudden stress was then transferred to the other davit arm which also broke about 4-1/2 in. above the center of the pivot pin. This caused the boat with the broken davit arms to fall to the water. This is shown in Figure 2.

of about 10,500 lbs. on the two davit arms or say 2.34 tons on each arm. The weights had just been placed on board & were being distributed a little better about the boat, when one of the arms was observed to be giving way, twisting & bringing the flat side of the arm to the front, after giving a little it suddenly bent down until the eye at the end of the arm was at the level of the operating screw, when it stopped. The middle portion of the bend is almost 3 ft. above the center of the pin on which the arm pivots. The rough sketch will give an idea of the appearance of the arm after bending. This arm is no. 12732, a test from which is shown on attached S.24. It was now arranged that all the davits should be tested with full equipment on board & weights representing the full number of persons & another boat of the same dimensions was loaded swinging in the davits, but not swung out, full equipment and 7168 lbs. on board, no men on board. The boat was then swung out & lowered about 40 ft. when one of the davit arms twisted and bent down., about 3' – 4" above the pivot pins & broke, the sudden stress this set up on the other arm broke it 4- ½" above the center of the pivot pin & the boat & broken pieces of davit arms fell into the water.

This paper refers to the failure of two sets of new Welin davits recently fitted on this vessel when being tested to the full weight of the boat, passengers & stores. In one case the davit bent down but did not fracture, but in the other case the arm was not sound & fracture occurred after the arm had bent down some little distance, the full load of 4.7 tons being then on the set of davits.

These davits as already mentioned are not apparently those originally fitted on the vessel, but additional ones to meet the new requirements. According to the rule in the new regulations regarding the date of launching the vessel, the davits should I think be passed, but each arm should be tested by a load of 1-3/4 tons which is approximately equal to the full load of the boat & 32 persons. The arms should be carefully inspected & any not wholly satisfactory should be rejected.

It is not reported what tests have been made of the davits originally fitted. If not already tested to the full load this should I think be done, but the loads in the first instance should be carefully applied & no one should be in the boat until it has been proved that the davit arms are sound & good & in every way sufficient.
