New Evidence of the Possible Danger of Loading Titanic's Lifeboats to Capacity

By Bob Read, D.M.D.

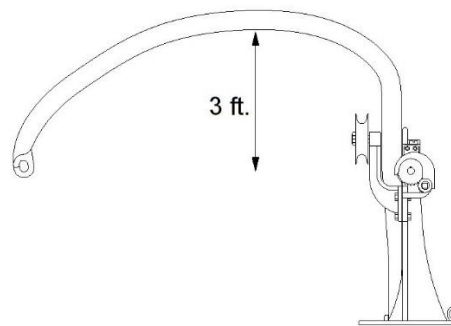
In order to simulate a fully loaded and equipped boat the water breaker in the boat was empty and there were two crew members in the boat in addition to 124 weights of 56 lbs. each. The specifics of the loading is detailed in the appendix. The boats were swung out to the gunwale. While the weights were being distributed, one of the davit arms was observed to be giving way. It twisted and was bent down until the eye of the davit was at the level of the operating screw when it stopped. Figure 1 is a recreation of the sketch which was included in the BoT documents.

The section of the last arm to break was quite sound & as shown here. The section of the first one to break was very defective & as shown in rough sketch. There was only 5/8" solid metal for 5" of the web with bad blow holes at each end as shown. The davits are of the type P2 & are 11'-4" from the center of pivot pin to the eye.

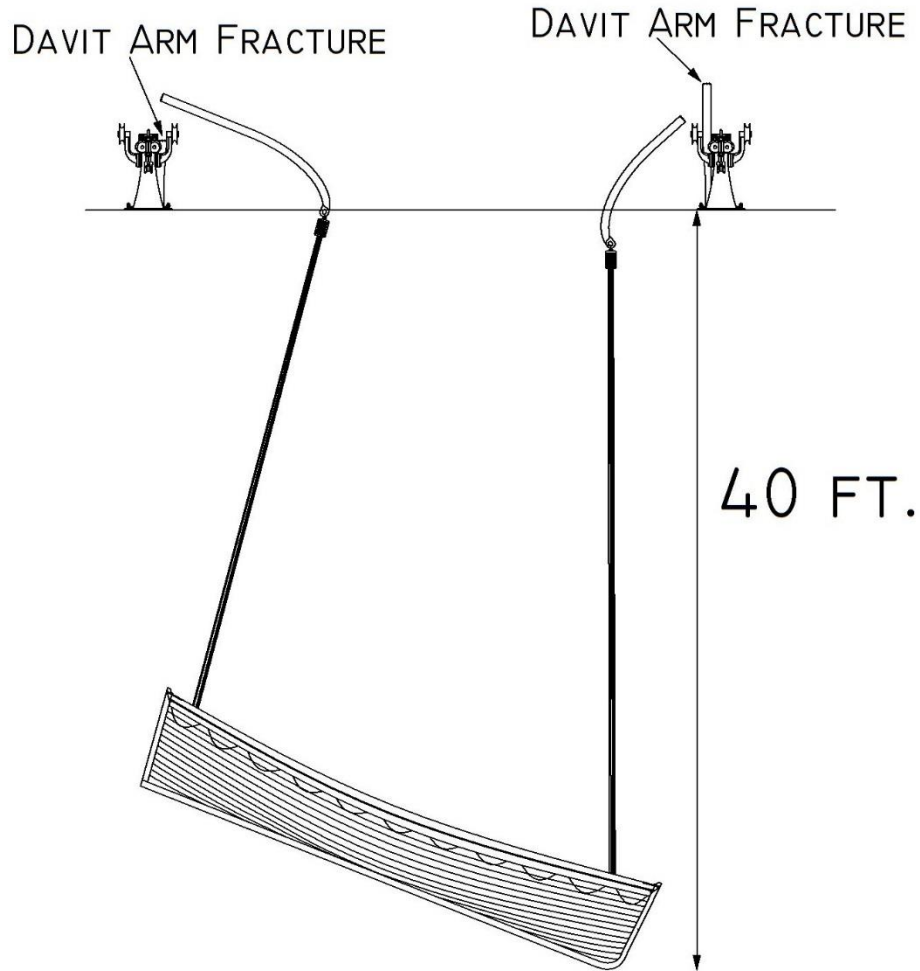
Figure 2

It was then determined that for safety reasons that the next davits and boat to be tested should be fully loaded before swinging out and that no crew should be on board. This next test proved to be catastrophic. The loaded, unmanned boat was swung out and lowered. When the boat had been lowered about 40 ft., one of the davit arms twisted and bent down, then broke about 3ft. 4in. above the pivot pins. This sudden stress was then transferred to the other davit arm which also broke about 4-1/2 in. above the center of the pivot pin. This caused the boat with the broken davit arms to fall to the water. This is shown in Figure 2.

This paper refers to the failure of two sets of new Welin davits recently fitted on this vessel when being tested to the full weight of the boat, passengers & stores. In one case the davit bent down but did not fracture, but in the other case the arm was not sound & fracture occurred after the arm had bent down some little distance, the full load of 4.7 tons being then on the set of davits.

These davits as already mentioned are not apparently those originally fitted on the vessel, but additional ones to meet the new requirements. According to the rule in the new regulations regarding the date of launching the vessel, the davits should I think be passed, but each arm should be tested by a load of 1-3/4 tons which is approximately equal to the full load of the boat & 32 persons. The arms should be carefully inspected & any not wholly satisfactory should be rejected.
