Titanic's B Deck Mystery Object

By Bob Read

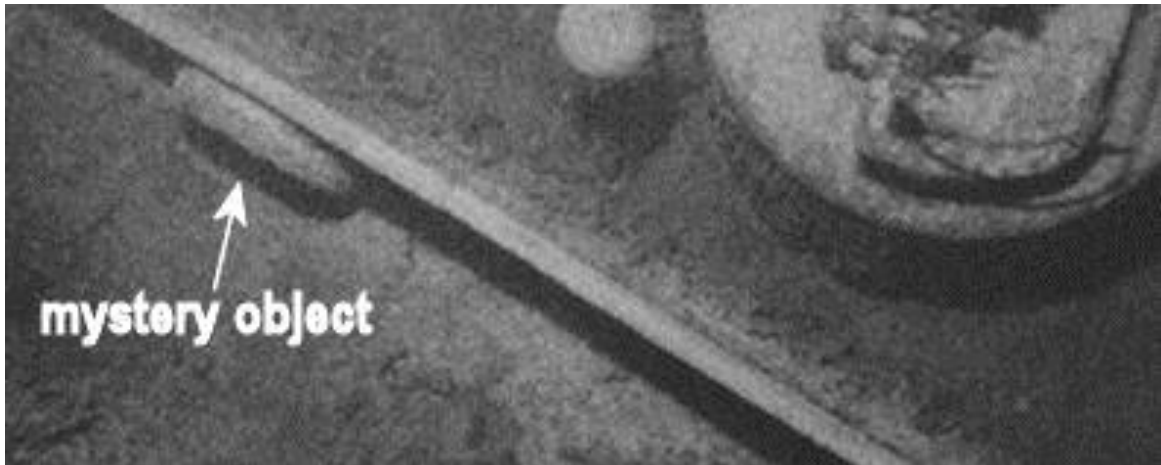
Figure 1

There are many mysteries of the structure of Titanic. One of these has been identified since the discovery of the wreck in 1985. It is an object which is seen in Figures 1&2 which is attached to the

inboard side of the forward promenade bulwark of B deck on the starboard side. The upper visible portion of the object is rounded on its upper inboard and outboard edges. It has the appearance of some sort of cover over something under it. A number of theories have been advanced which attempt to explain the function of the structure and more specifically, what is under it. Because we can't see under this object, the definitive answer as to the function of either the object or what is beneath it has remained unresolved. The purpose of this paper is to examine the various theories to determine which might better fit the facts as we know them. Individual aspects of the theories will be tested to see how strong the evidence is which supports them.

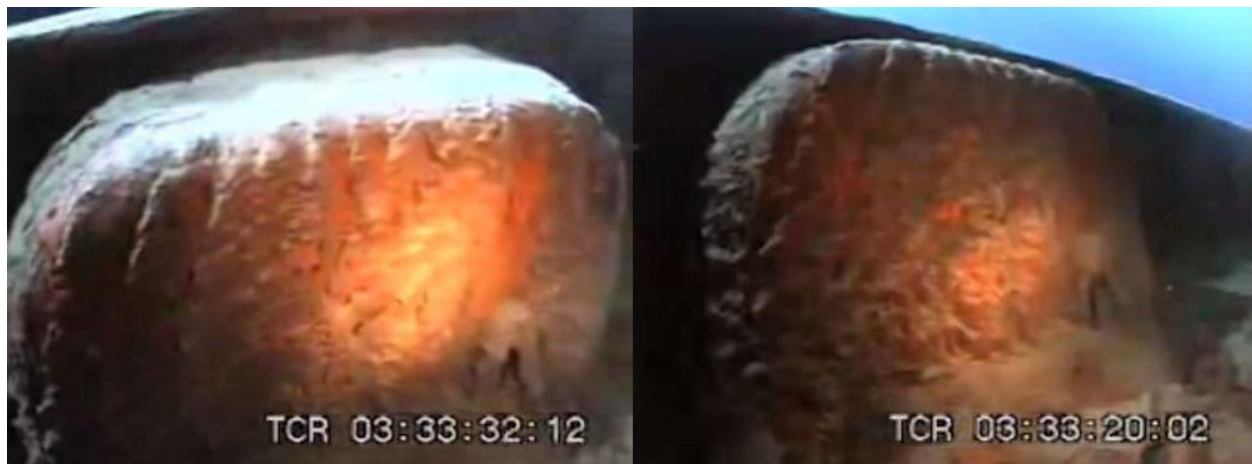
Figure 2

Problem: It is not. Because in early photos taken from directly above, it was assumed that this object was circular. In James Cameron's 2001 dive to Titanic, special attention was given to this object. As can be seen in Figure 2, the object is rectangular with rounded upper corners, not circular.

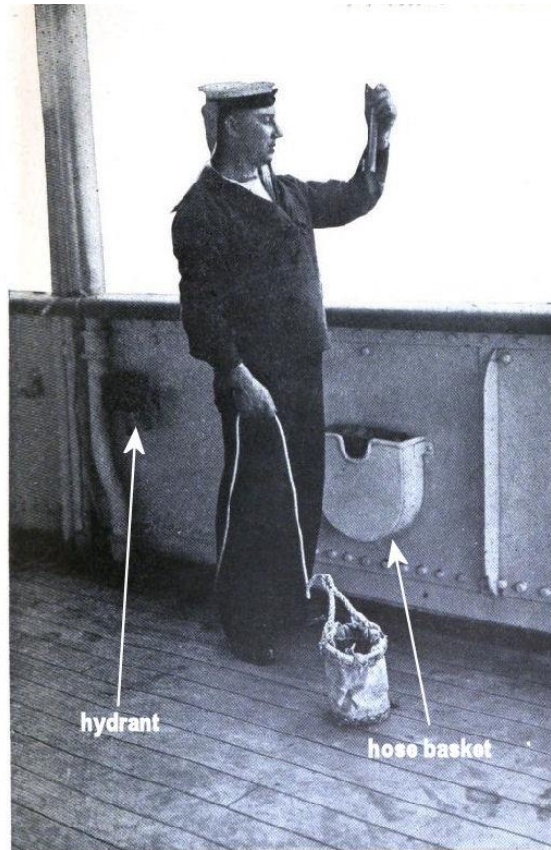
Figure 3

Problem #3: If the cover protects a hose basket, it is much larger than the hose baskets on other bulwarks. See figure 3.

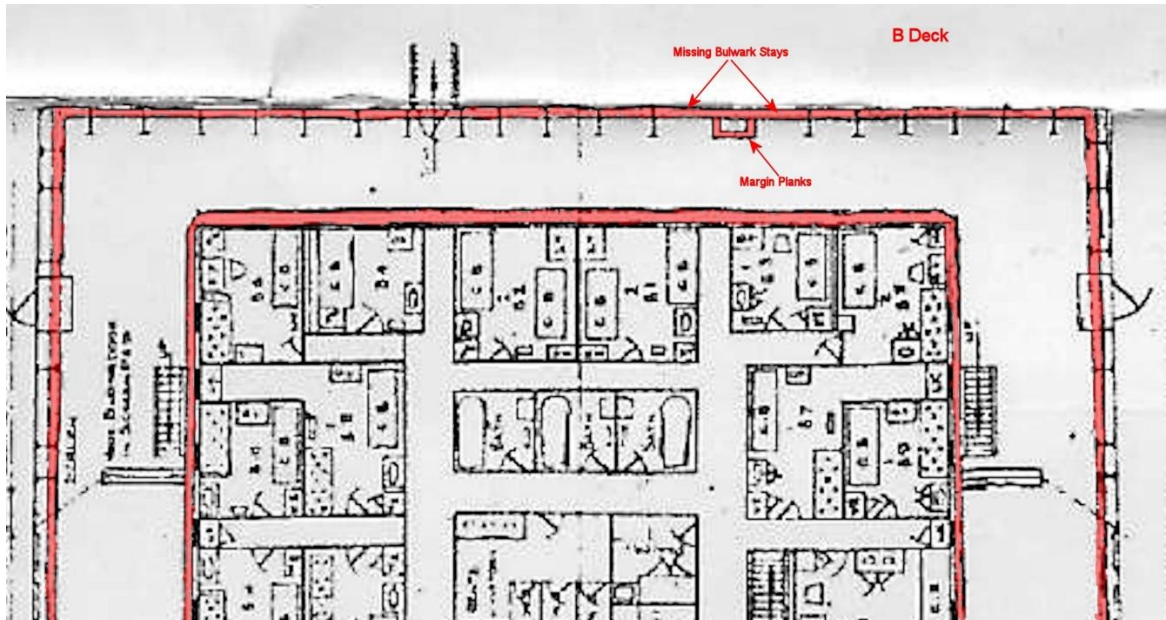
- * The mystery object is metal.
- * The bulwark stays flanking the object are missing as can be seen in Figure 6
- * There is teak margin planking around the object as can be seen in Figure 6.
- * The object is centered 12 ft. to starboard of the midline.
- * On plans of the ventilation systems and water systems there is nothing indicated in this area.
- * It is not known if there is any electrical service to this area because we don't have detailed plans of the electrical distribution aboard.
- * *Olympic* had this same object in the same location on her maiden voyage. The object was later removed but we are unable to establish a precise date. We do know that it was not present by sometime in the 1920s.
- * *HMHS Britannic* didn't have this object installed.

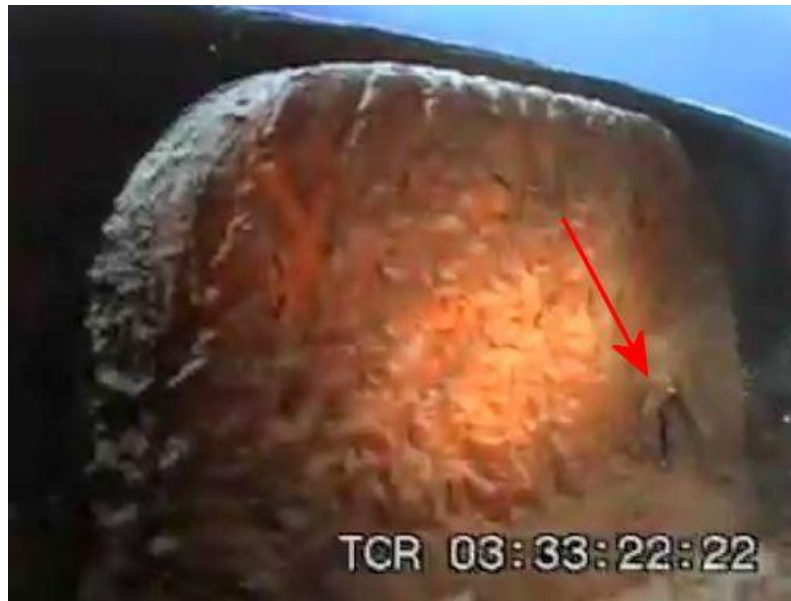
Figure 8

On the aft face of the object in the lower right quadrant there appears to be another protrusion which is obscured by rusticles. This is shown in figure 8.
