Titanic's Chart Room and Pilot's Room Windows

By Bob Read, D.M.D.

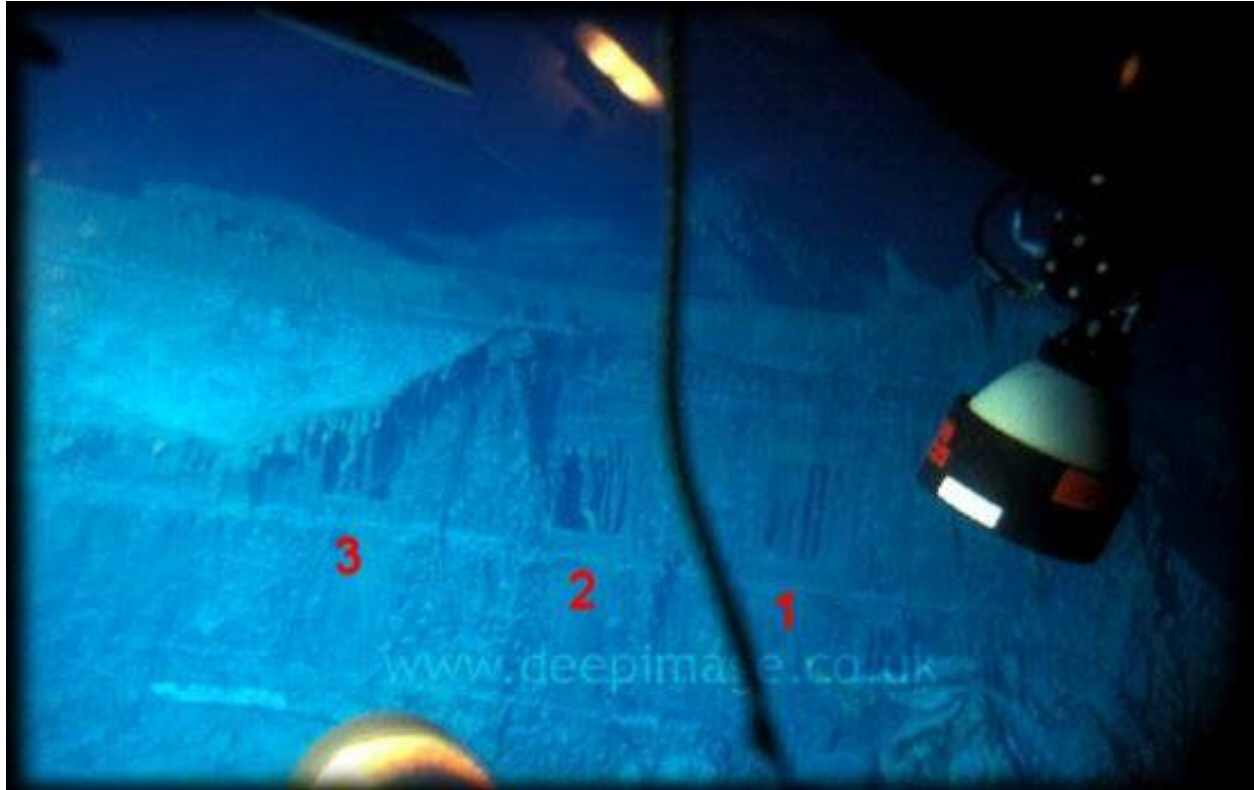
the pilot's room by placing light and air "windows" on the aft bulkheads of these rooms. These were not conventional windows in the sense that one could look out of them to have an exterior view. These windows opened into the fan trunk forward of the first funnel. They were directly below the stokehold duct over the fan trunk. Ambient light in the upper part of the fan trunk provided light through these windows. It is probable that they had translucent glass which they referred to as "obscure glass" to diffuse the light for greater illumination in the rooms. By some means the windows could be opened to allow air to enter. Figure 2 shows a wreck photo showing these three windows.

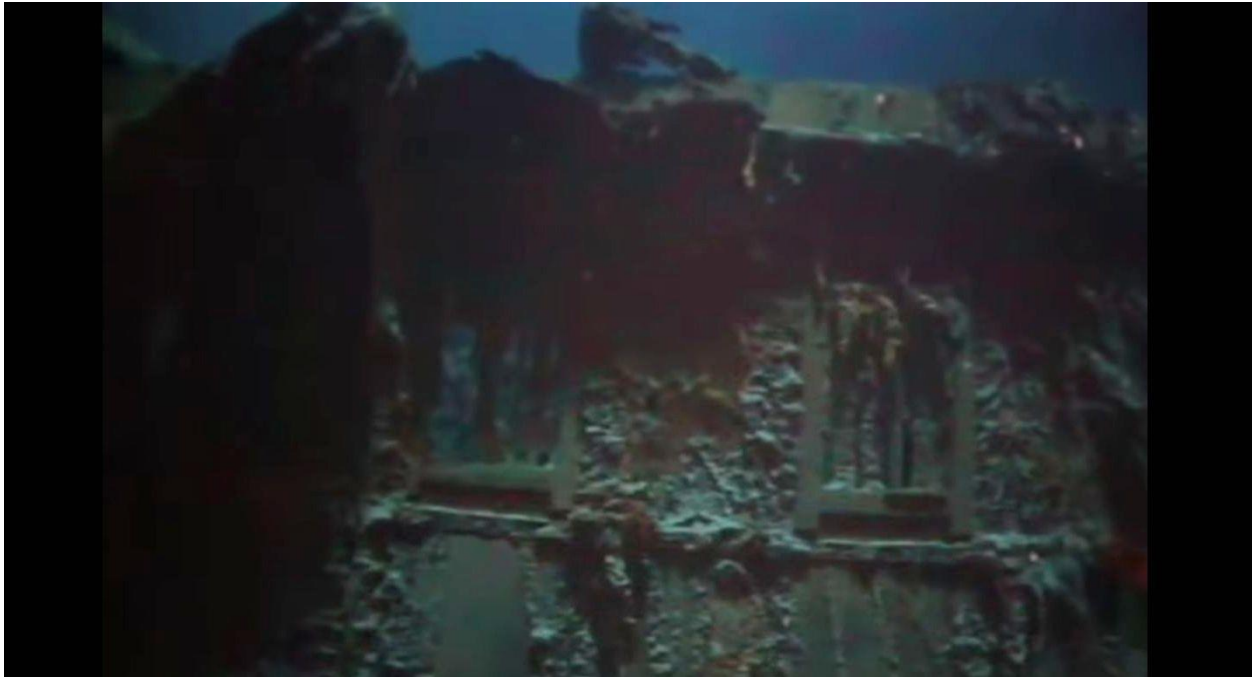
Figure 3 shows a closer view of two of the windows.

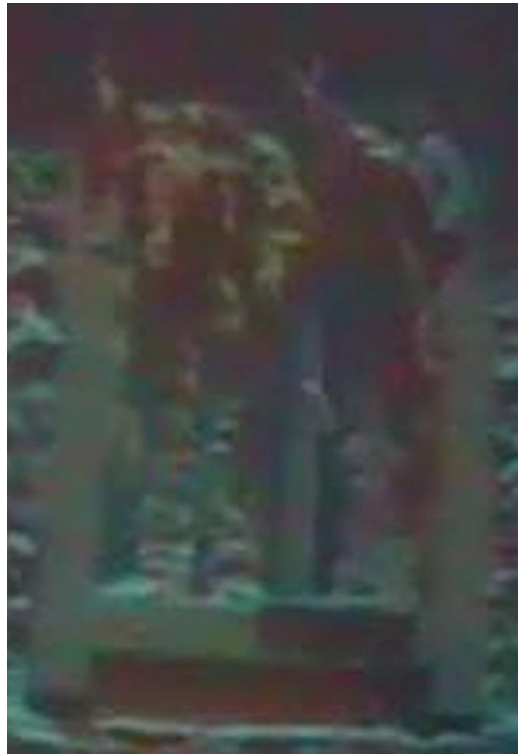
Figure 4 shows an enlargement of one of the windows.
