Intake Guards for *Titanic's* 35-inch Electric Fan Ventilators

By Bob Read, D.M.D.

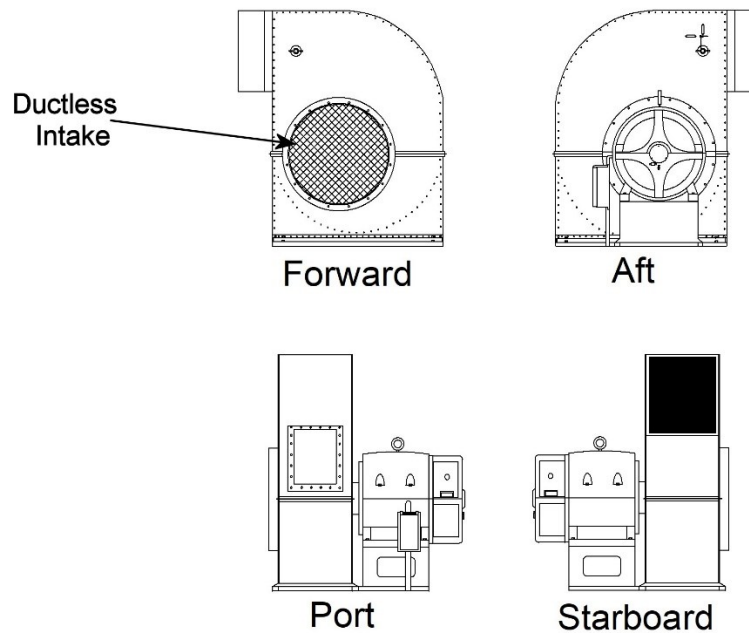
The type of electric fan ventilator which will be discussed in this article is of a specific type. It is the 35 in. sirocco electric fan ventilator with no intake ducting such as the swan neck duct which is often seen paired with this particular ventilator. In Figure 1 we see a drawing of this type of ventilator.

35-inch sirocco electric fan ventilator with no intake duct

The intake opening is covered by a screen. The problem with placing this type of ventilator in areas which have passenger access is that items could be inserted through the screen which could either damage the fan blades or cause injury to a passenger. In order to prevent this, one method which was employed was to place guard railings which restricted access to the intake opening. Figure 2 shows this type of ventilator outside the first-class entrance on the port boat deck of *Olympic*. You can see guard railings attached to the ventilator and the entrance bulkhead to prevent access to the open intake of the ventilator.

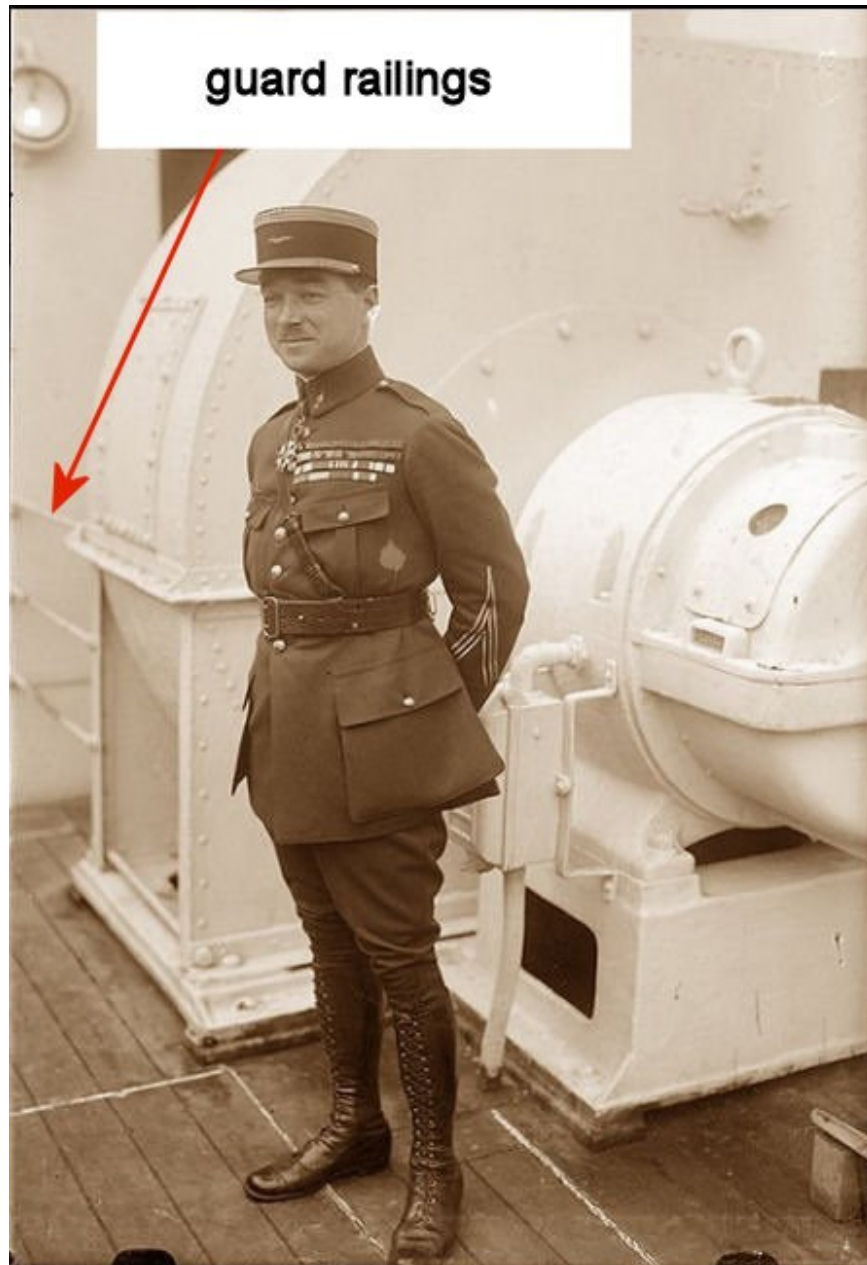
Figure 2

Guard railings protecting intake opening

It was thought that this guard railing method was employed for all the ductless intakes of the 35 in. ventilators on *Titanic's* boat deck. Recent study of a similar type of ventilator on H.M.H.S. *Britannic* has caused a re-examination of the assumption about guard railings being used to guard the intakes of these 35 in. ventilators. The first Olympic evidence that confirmed that intake guards were used on her later installed 35 in. ductless ventilators was a photo of the special inverted 35 in. ventilator on the starboard aft corner of the deckhouse under the third funnel. This ventilator is shown in Figure 3. You can see that an extension with its own screen guard is bolted to the intake. This puts distance between the outer screen and the intake opening and prevents any easy access to the intake without having to install guard railings around the ventilator.

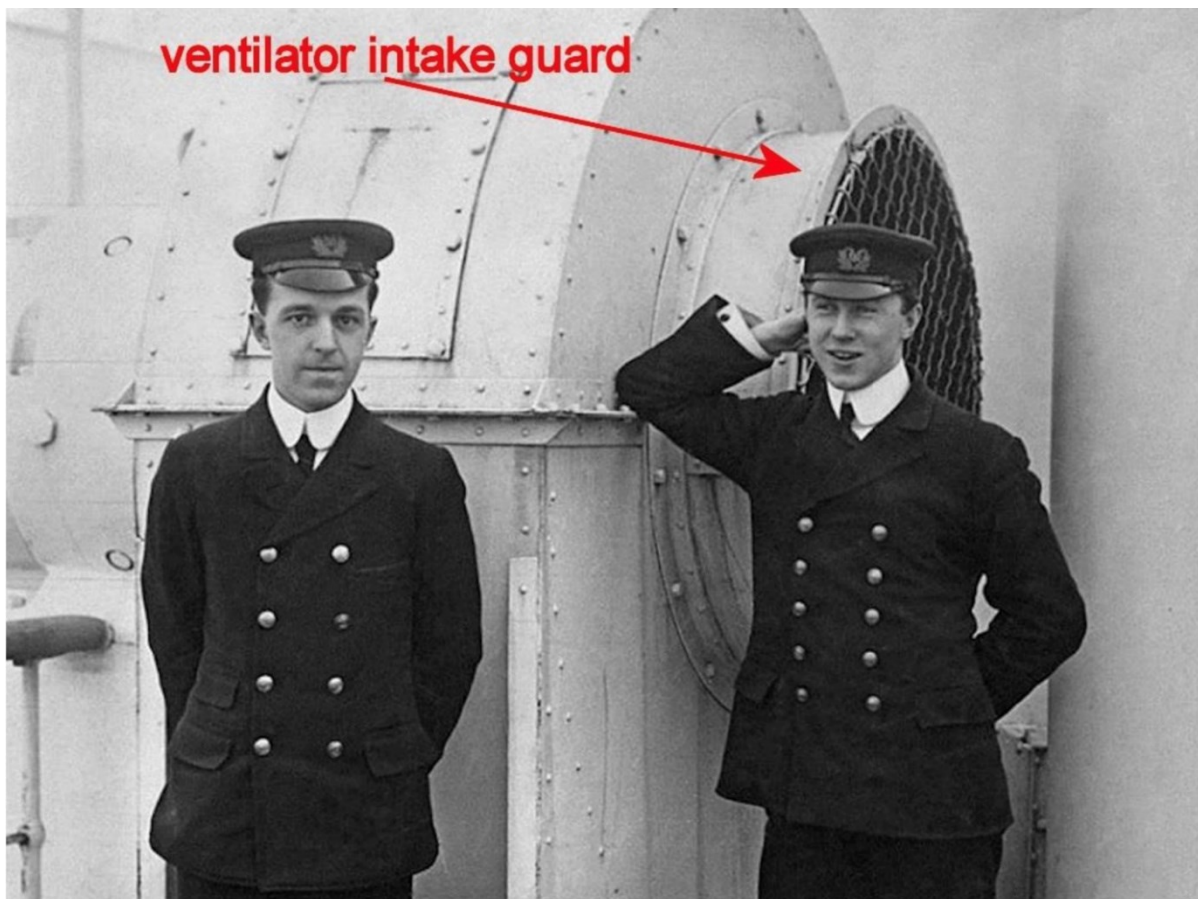
Figure 3

Ventilator intake guard on *Olympic*

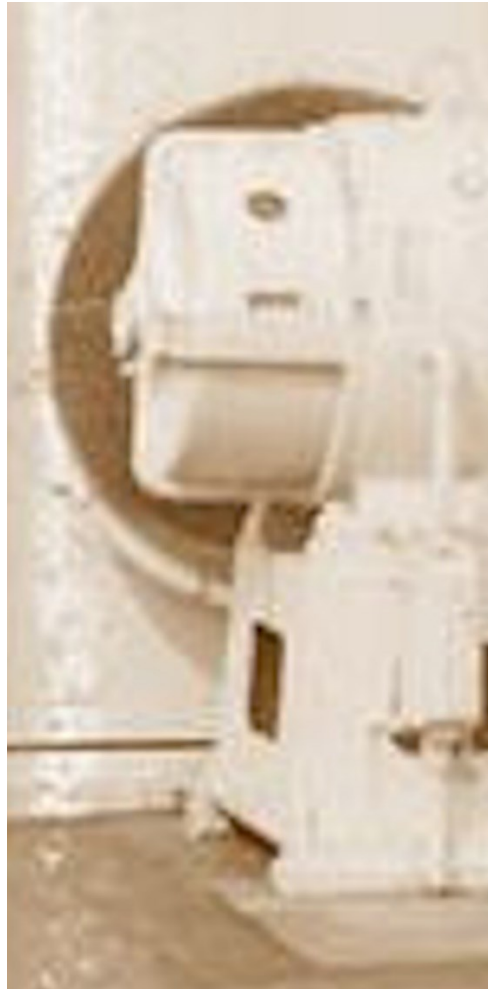
Titanic had an identical ventilator in the same location. The next location which would let us know if this type of intake guard was used with the conventional configuration of the 35 in. ductless ventilator was on the starboard forward aspect of the deckhouse under *Olympic's* third funnel. In Figure 4 we see the intake of this ventilator. It is more difficult to see the intake

guard from this angle but the lower part of the opening shows an interior ledge which indicates that an intake guard is in place.

Ventilator intake guard on *Olympic*

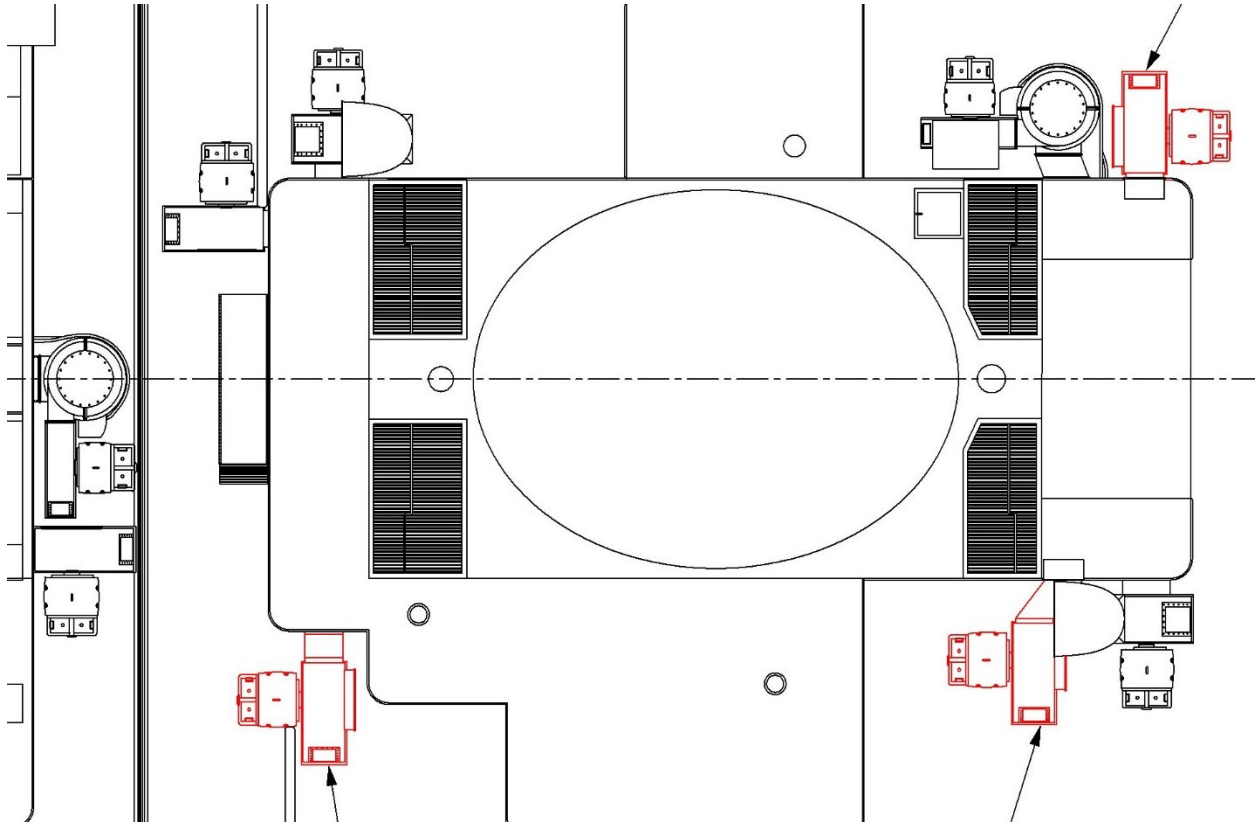
All of these types of ventilators with intake guards for which it is proposed that *Titanic* would have had, do not have visible intake guards in any photos of *Titanic* and they are missing from the wreck. I believe it is reasonable to extrapolate the *Olympic* evidence to *Titanic*. There are numerous other examples where we have had to do this and I don't believe it is unreasonable in this case. Figure 5 shows the three ventilators on *Titanic* in red which would have had these intake guards. The 35 in. ventilator on the aft side of the third funnel deckhouse and the one on the forward side of the tank room were within the engineer's promenade and, as such, the area was off limits to passengers.

35 in. ductless ventilators on *Titanic* with intake guards

Olympic and *Britannic* evidence suggests that the three 35-inch ductless electric fan ventilators which were near the third funnel deckhouse of *Titanic* had their intake openings protected with an extended intake guard. There is no direct *Titanic* evidence but many ventilator installations on the three sister ships had close similarities such that it is not unreasonable to extrapolate for the *Olympic* evidence to *Titanic*.
