Paint Application to *Titanic's* Propellers

by Bob Read, D.M.D.

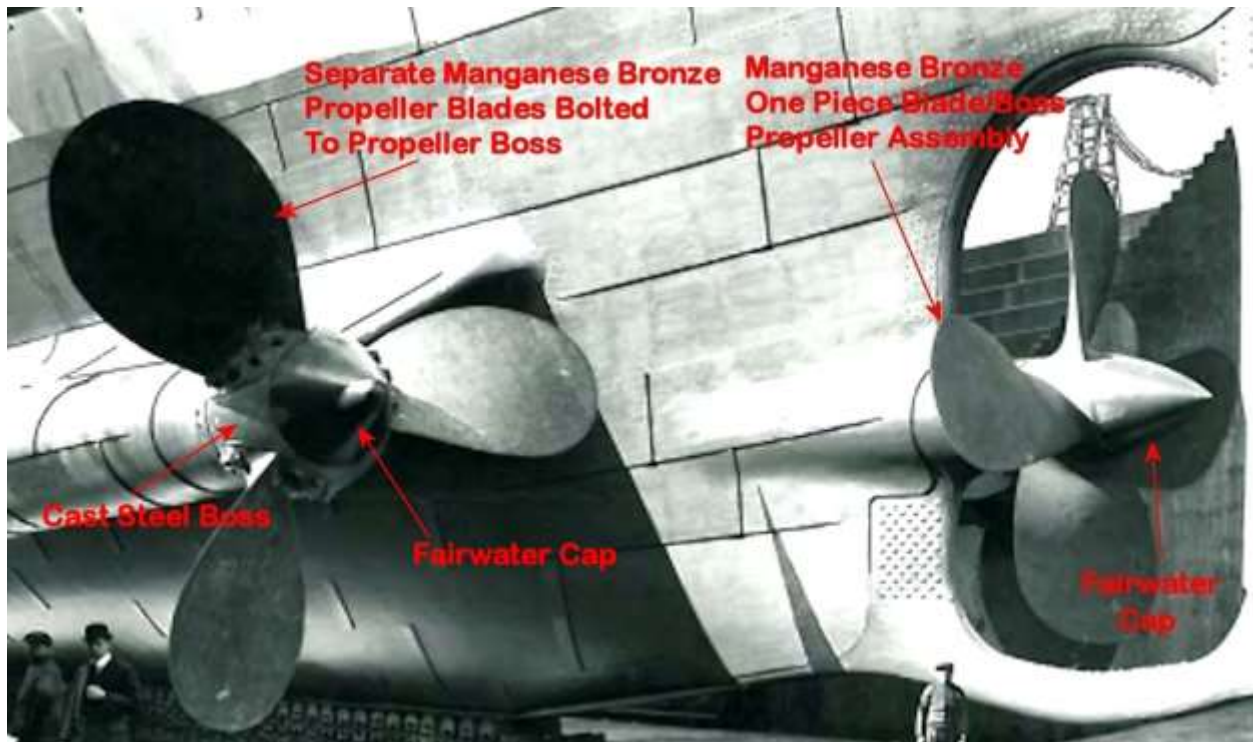
Figure 1

In order to establish a common frame of reference, the individual propeller components which will be referenced in this discussion are shown in Figure 1.

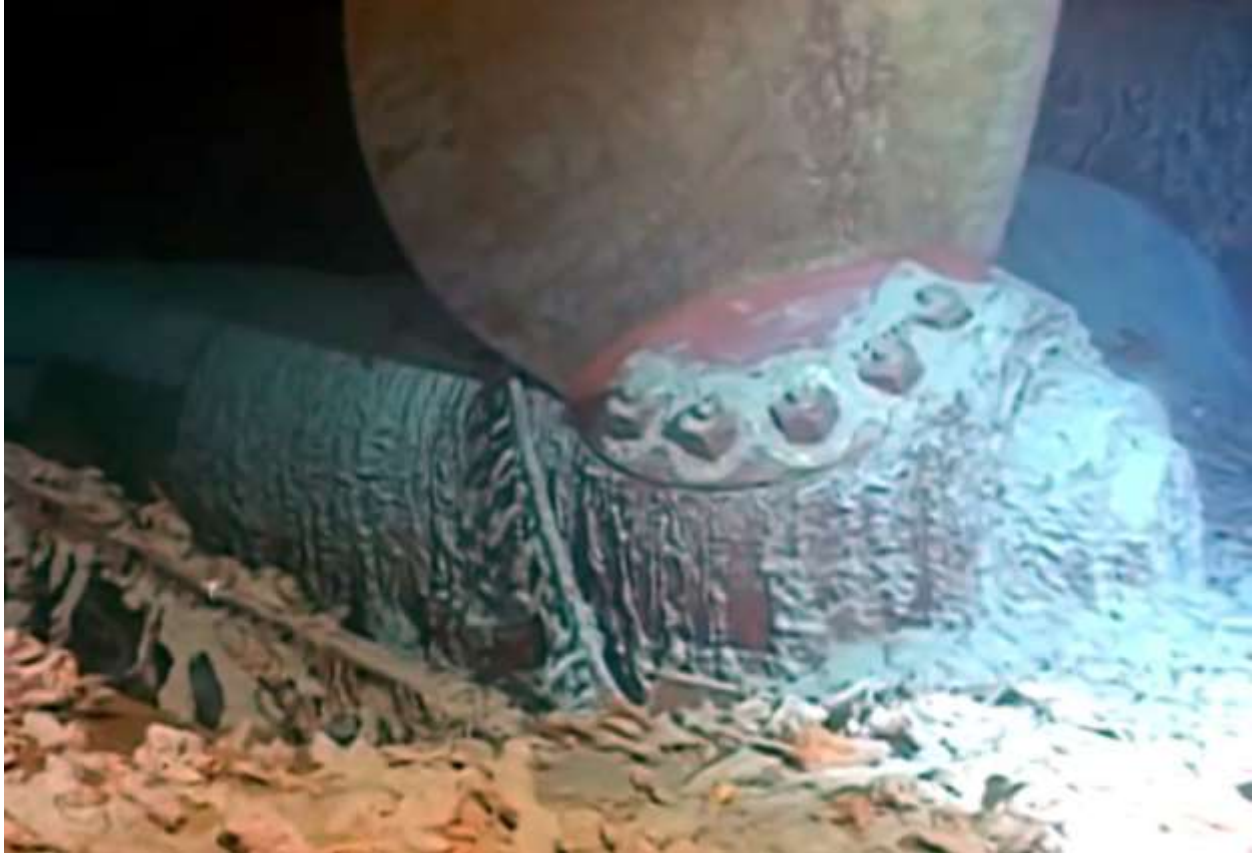
Figure 2 shows the photo evidence for paint which was applied to the wing propeller assemblies. As can be seen in this *Titanic* wreck photo, there are antifouling red paint remnants on the steel boss and the root of the bronze propeller blade.

The propeller component that is missing on the wreck is the fairwater cap. Since it is mated to the cast steel propeller boss, it is a reasonable assumption that the fairwater cap is cast iron/steel. As such, it is also reasonable to assume that the bare steel of the fairwater cap would be protected with antifouling red paint.

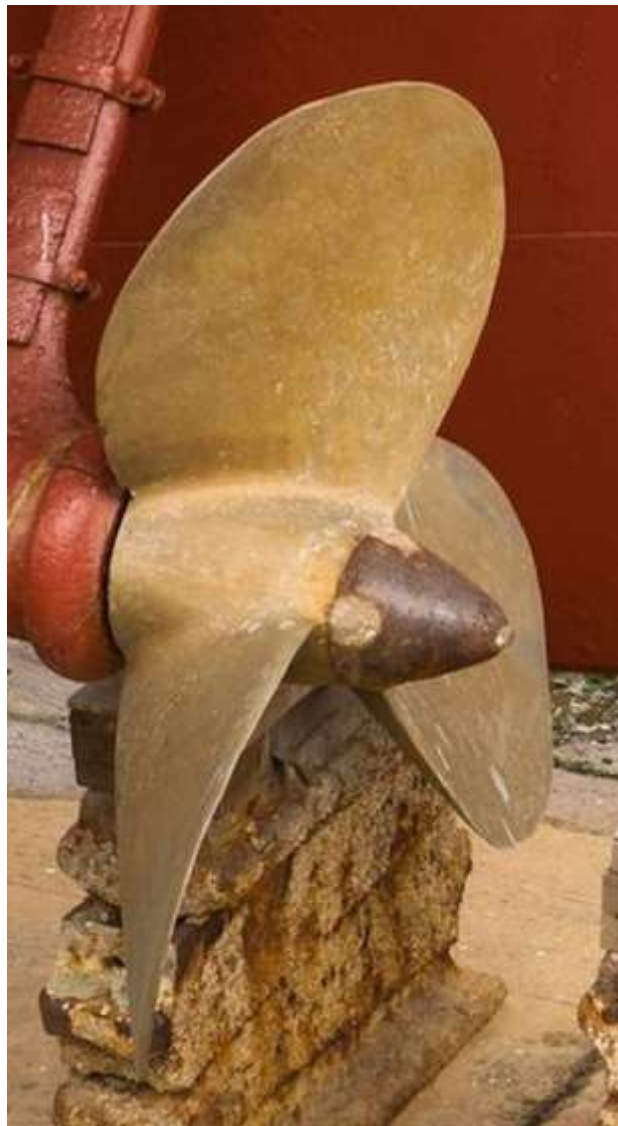
The center propeller is a one piece manganese bronze casting consisting of the blades and the boss. The only separate part of the center propeller is the fairwater cap. Since the boss and blades of the center propeller are bronze, it was initially assumed that the fairwater cap would also be a matching bronze. Recent photo evidence from S.S. *Nomadic* has changed the thinking about the fairwater cap. In Figure 3 it can be seen that on *Nomadic* the propellers were the same cast manganese bronze as *Titanic*. It can also be seen that the fairwater cap is not bronze. It is clearly a ferrous metal which is most likely cast iron or steel. The reason this

evidence is significant is because *Nomadic* was built at Harland and Wolff which is the same shipyard where *Titanic* was built. *Nomadic* was launched within one month of *Titanic* so they are close contemporaries. It is reasonable to expect that the same shipyard practices would be in place for both ships. Therefore the most reasonable assumption is that the fairwater cap for *Titanic's* center propeller fairwater cap was cast iron/steel and was protected with antifouling red paint. In the *Nomadic* photo, the fairwater cap is unpainted. This is because the ship was in the process of restoration when this photo was taken.
