Paint Application to *Titanic's* Propellers

by Bob Read, D.M.D.

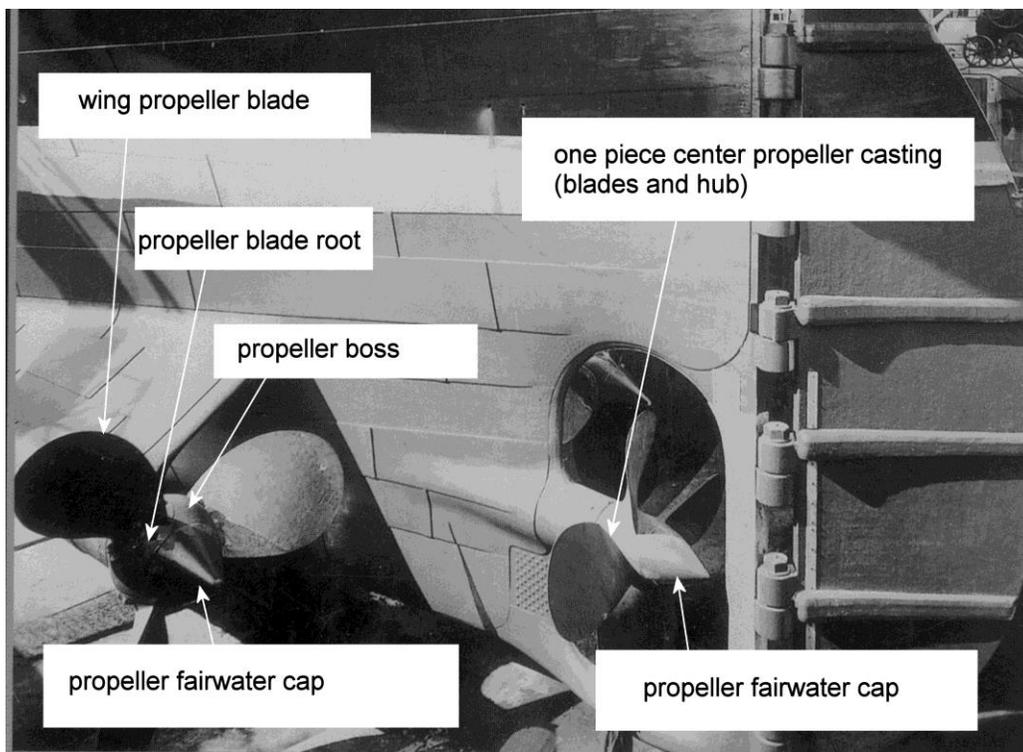
Figure 1

In order to establish a common frame of reference, the individual propeller components which will be referenced in this discussion are shown in Figure 1.

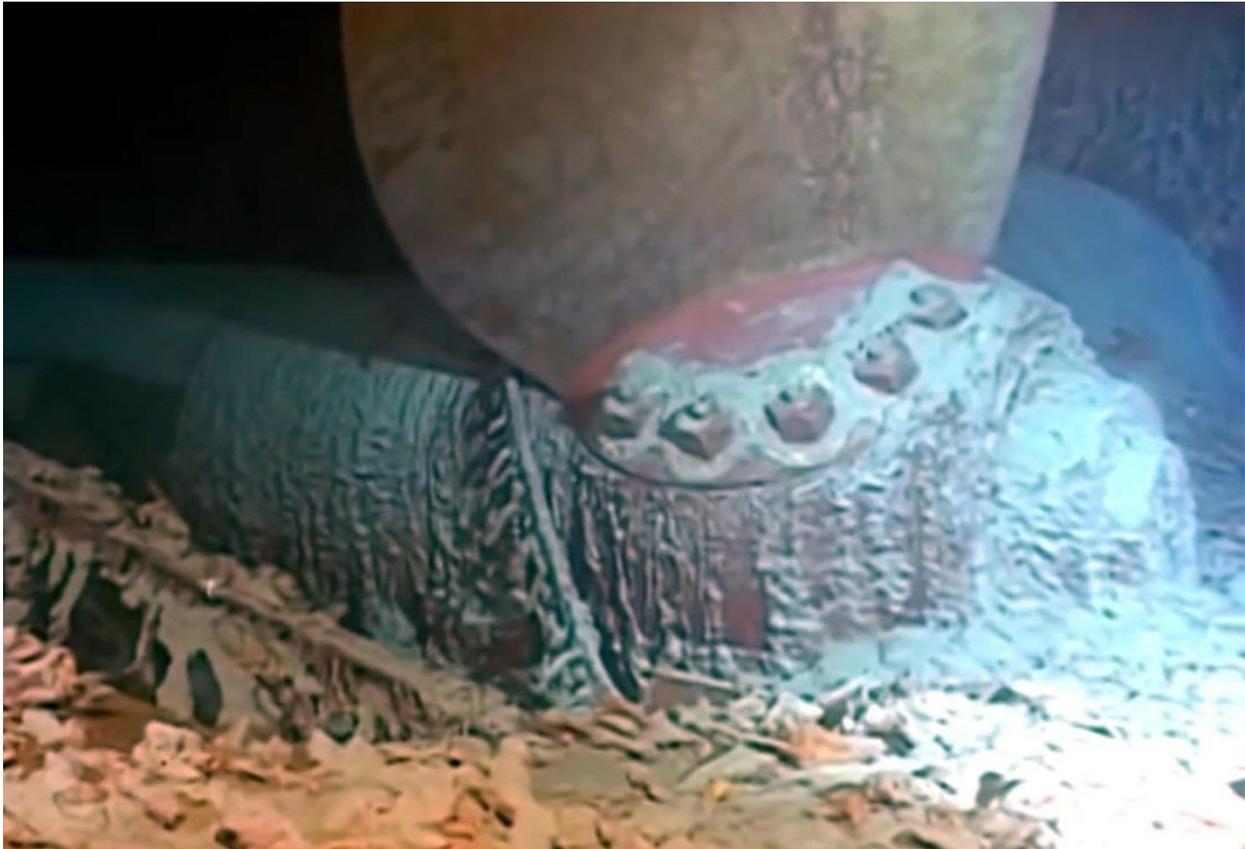
Figure 2 shows the photo evidence for paint which was applied to the wing propeller assemblies. As can be seen in this *Titanic* wreck photo, there are antifouling red paint remnants on the steel boss and the root of the bronze propeller blade.

The propeller component that is missing on the wreck is the fairwater cap. Since it is mated to the cast steel propeller boss, it is a reasonable assumption that the fairwater cap is cast iron/steel. As such, it is also reasonable to assume that the bare steel of the fairwater cap would be protected with antifouling red paint.

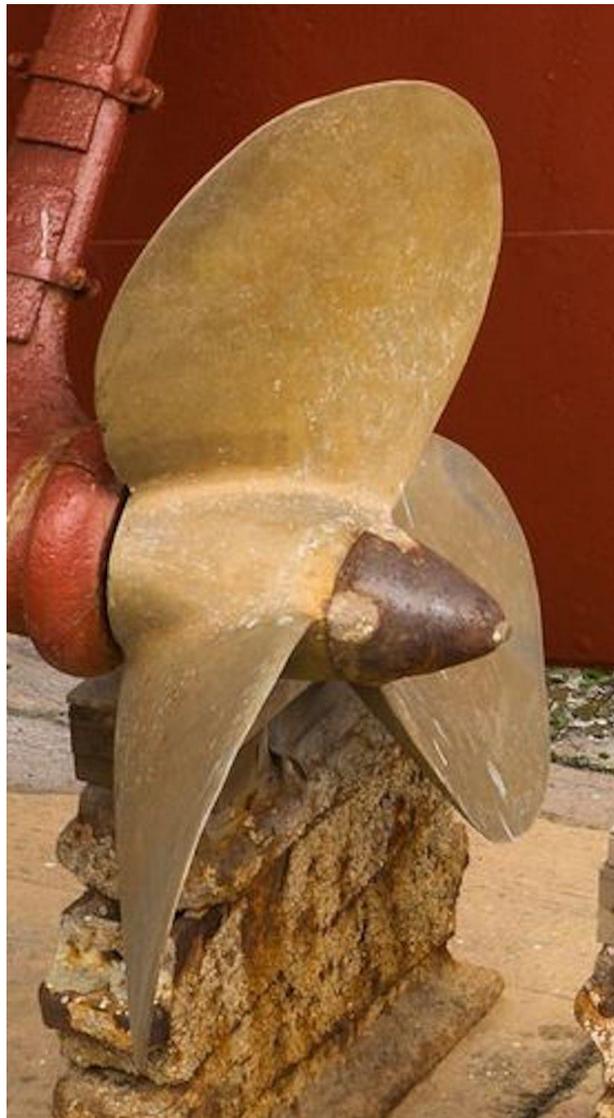
evidence is significant is because *Nomadic* was built at Harland and Wolff which is the same shipyard where *Titanic* was built. *Nomadic* was launched within one month of *Titanic* so they are close contemporaries. It is reasonable to expect that the same shipyard practices would be in place for both ships. Therefore the most reasonable assumption is that the fairwater cap for *Titanic's* center propeller fairwater cap was cast iron/steel and was protected with antifouling red paint. In the *Nomadic* photo, the fairwater cap is unpainted. This is because the ship was in the process of restoration when this photo was taken.

The center propeller is a one piece manganese bronze casting consisting of the blades and the boss. The only separate part of the center propeller is the fairwater cap. Since the boss and blades of the center propeller are bronze, it was initially assumed that the fairwater cap would also be a matching bronze. Recent photo evidence from S.S. *Nomadic* has changed the thinking about the fairwater cap. In Figure 3 it can be seen that on *Nomadic* the propellers were the same cast manganese bronze as *Titanic*. It can also be seen that the fairwater cap is not bronze. It is clearly a ferrous metal which is most likely cast iron or steel. The reason this

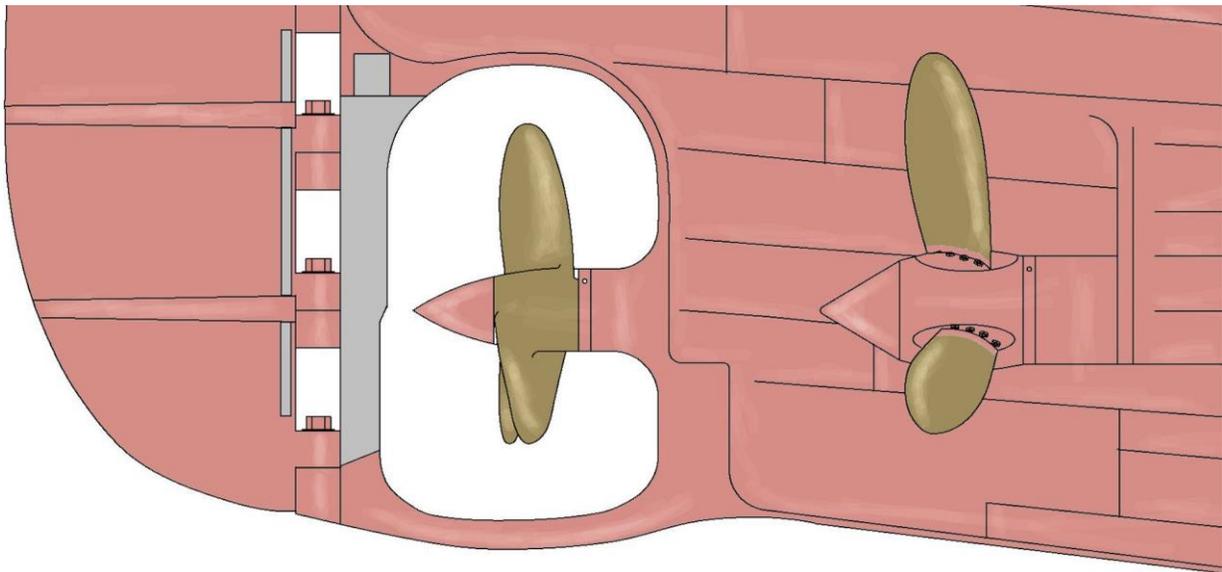
Figure 4 is a drawing showing where the propeller components were painted antifouling red.

Wing propellers: Propeller blade root, boss, and fairwater cap all painted antifouling red

Center Propeller: The center propeller had its fairwater cap painted antifouling red.
